# UNDERWATER BRIDGE INSPECTION REPORT

STRUCTURE NO. 69536

CHANNEL AT LAKE VERMILLION

MINNESOTA DEPARTMENT OF TRANSPORTATION  
UNDERWATER BRIDGE INSPECTION

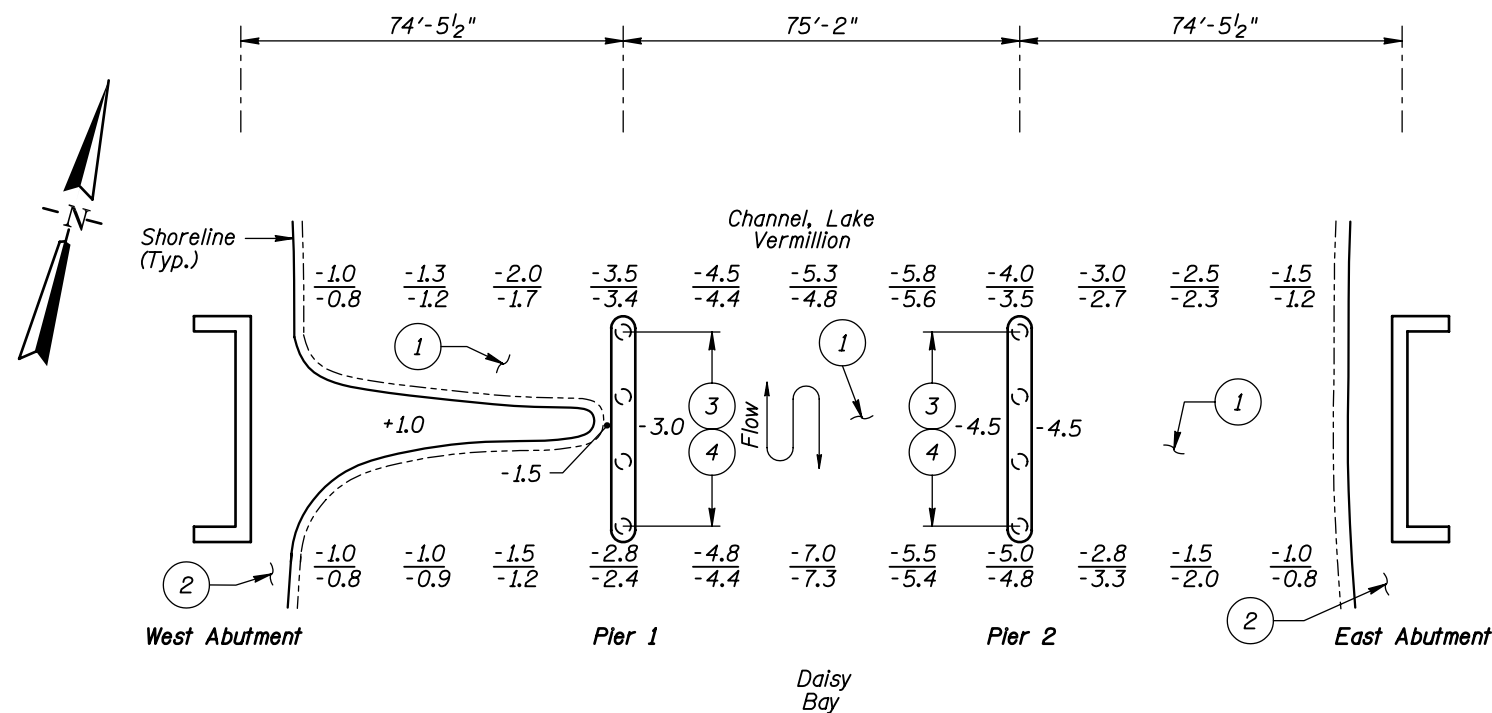
#### INSPECTION AND SOUNDING PLAN

- The channel bottom material typically consisted of firm sand with scattered riprap up to 18 inches in diameter and a maximum probe rod penetration of 1 to 3 inches.
- Both shorelines were well protected with 12 to 36 inch diameter riprap material along the banks.
- The steel pipe piles exhibited 50 to 100 percent coating failure and surface corrosion from 6 inches above the waterline to 6 inches below the waterline.
- The steel pipe piles exhibited 50 to 75 percent coating failure from 6 inches below the waterline to the channel bottom with heavy nodular corrosion, ranging in size from 1 to 1.5 inches in diameter. Rust nodules exhibited typical pitting of 1/32 inches in depth and up to 1/16 inches deep.

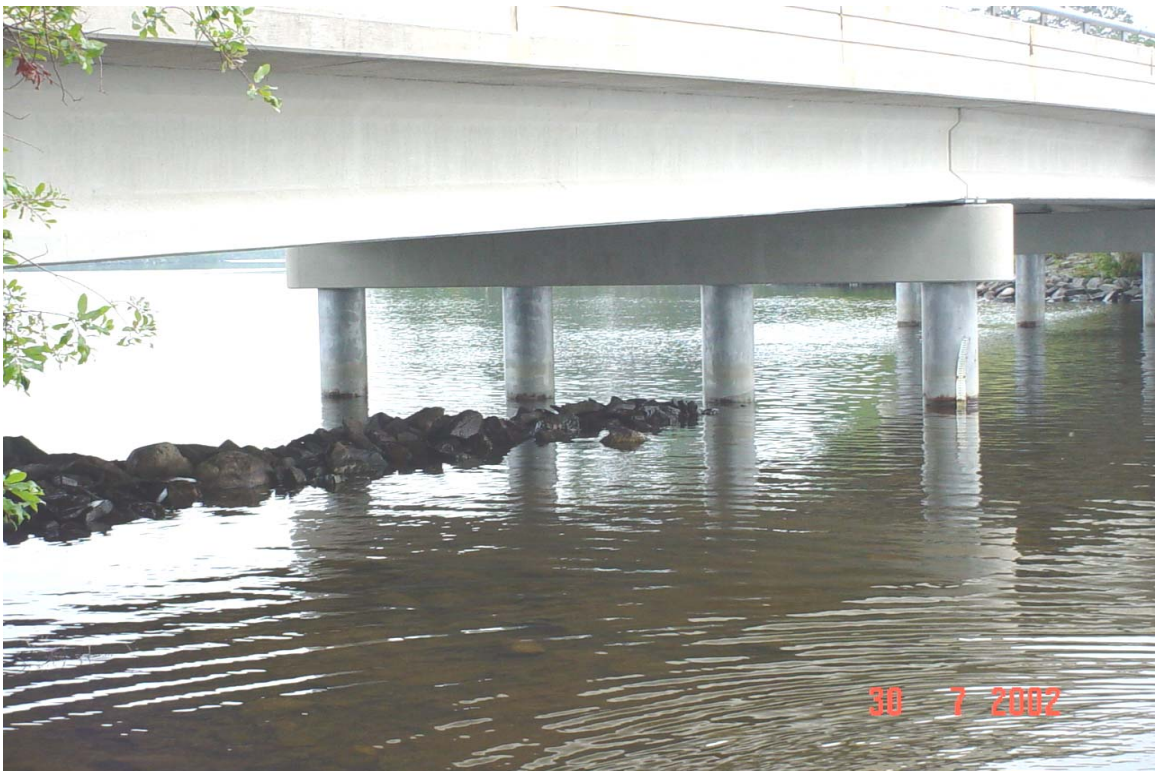
Photograph 2. View of Pier 1, Looking Northeast.

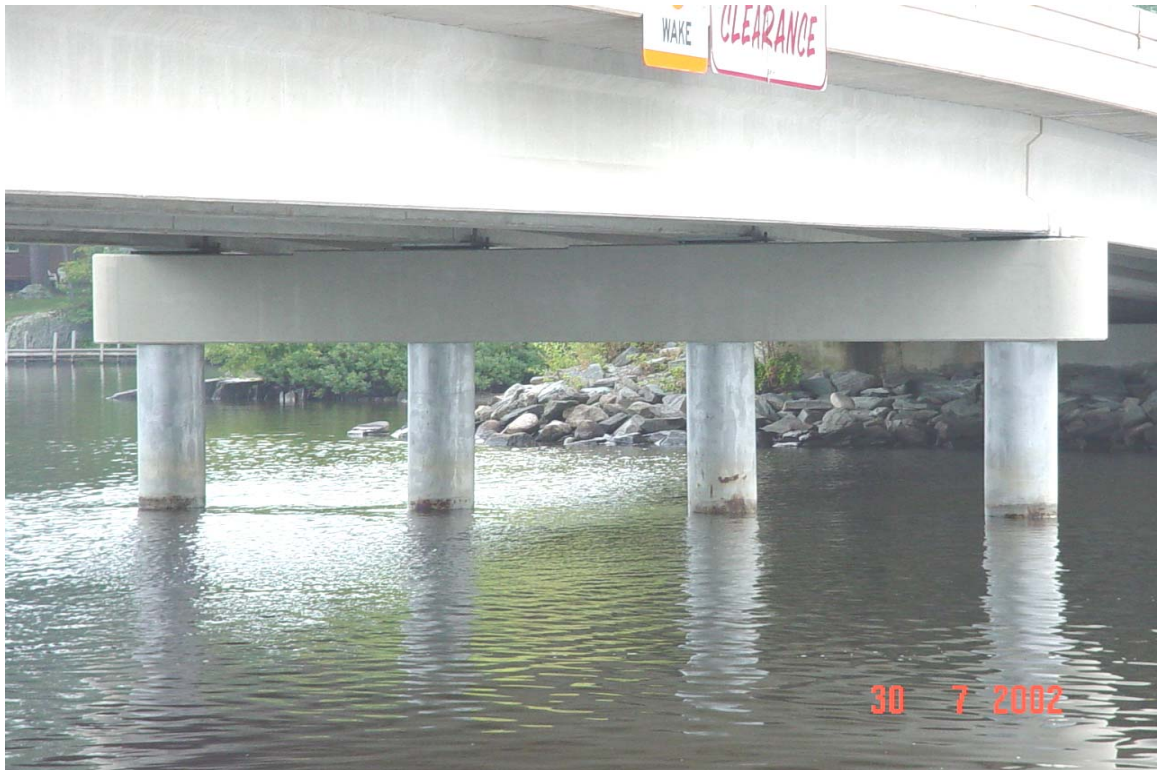
Photograph 3. View of Pier 2, Looking Northeast.

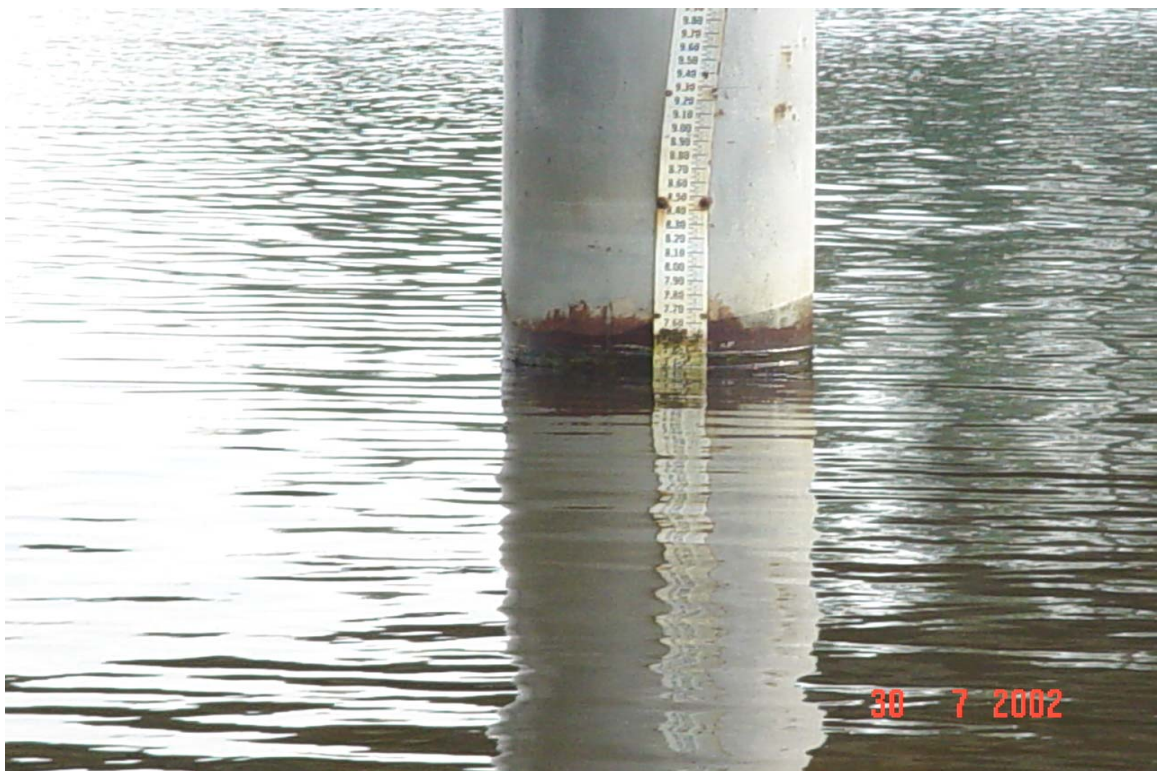
- (A) The steel pipe piles exhibited 50 to 100 percent coating failure and surface corrosion from 6 inches above the waterline to 6 inches below the waterline.
- (B) The steel pipe piles exhibited 50 to 75 percent coating failure with heavy nodular corrosion, with nodules that were 1 to 1.5 inches in diameter and with typical pitting of 1/32 inch in depth and up to 1/16 inch deep, from 6 inches below the waterline to the channel bottom.

Photograph 4. View of Typical Corrosion of the Steel Pipe Piles, Looking Northeast.

- (A) Reinspect the submerged substructure units at the normal maximum recommended (NBIS) interval of five (5) years.
